**PRELIMINARY ASSESSMENT/  
VISUAL SITE INSPECTION**

**CLIFF DORION FACILITY  
(A.K.A. CLIFFS CONTAINER FACILITY)  
ROMEOVILLE, ILLINOIS  
ILD 000 768 481**

**FINAL REPORT**

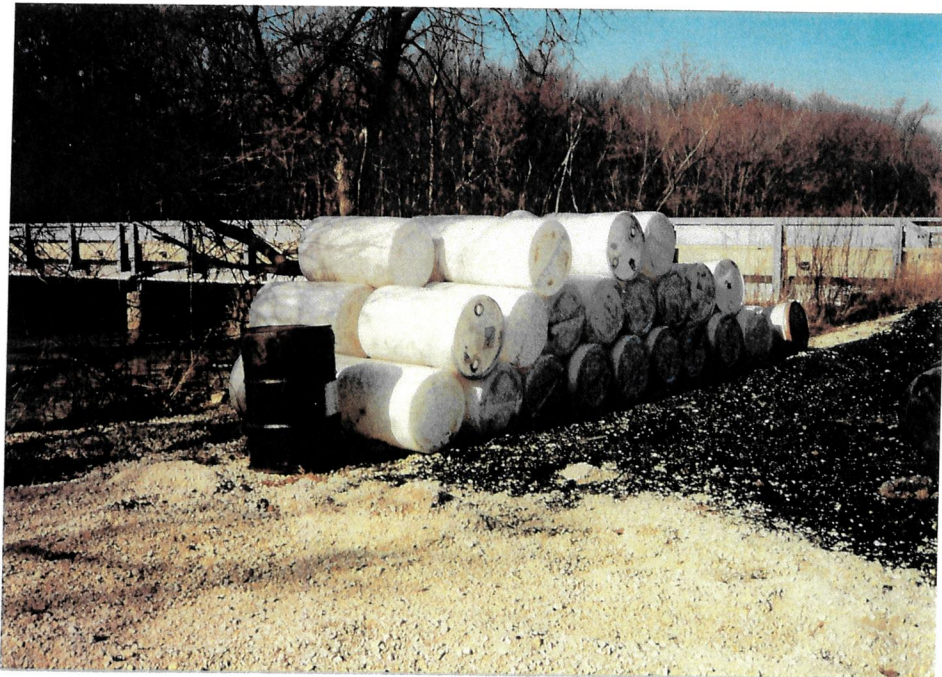
**Location:** SWMU 1  
**Date:** February 4, 1993

At the time of the VSI, the area where this unit is located was recently covered with fresh gravel and the unit contained approximately 160 empty drums. There were no stains or evidence of a previous release (see Photo No. 1).

**Photo No.:** 1  
**Orientation:** Northwest  
**Description:** Approximately 40 55-gallon plastic drums stored in the Front Drum Storage Area. These drums formerly contained yeast and other food products.

The facility should also continue to monitor all drums brought to the facility and inspect this unit to verify no drums with hazardous waste residue are present. If detected, such drums should be immediately closed and transported off-site to a permitted RCRA TSD facility for disposal.

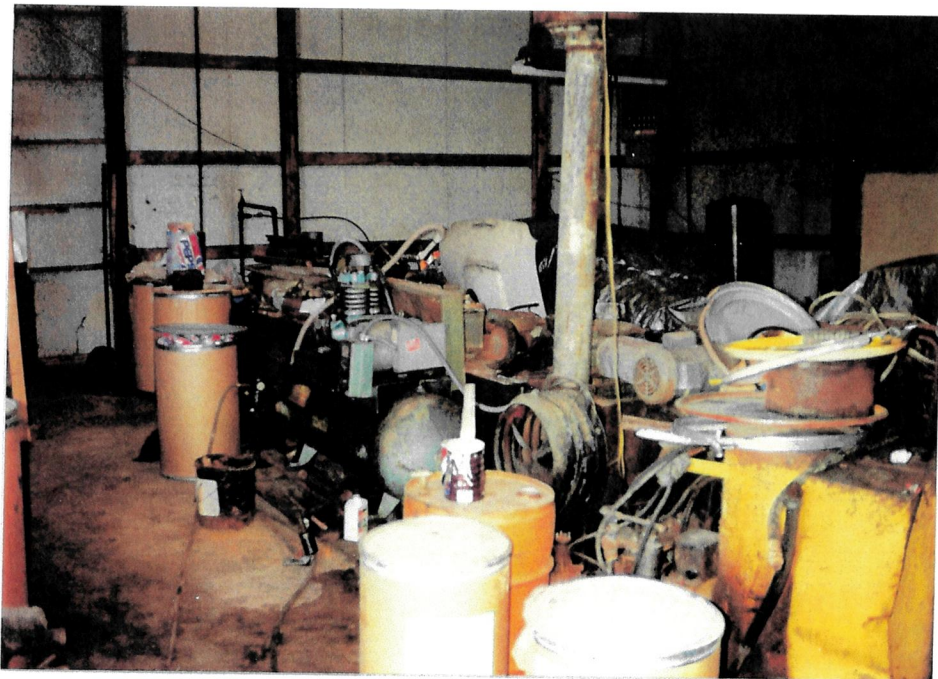
**Location:** SWMUs 4 and 5  
**Date:** February 4, 1993

**Observations:** Dynamac did not observe this unit during the VSI because it had been removed from the facility in the mid-1980s. The area where this unit was formerly located did not contain any stains or evidence of a previous release (See Photo No. 2).

**Photo No.:** 2  
**Orientation:** East  
**Description:** The Wash Bath (SWMU 5) is located near center of photograph under the miscellaneous equipment and debris. The Furnace (SWMU 4) was formerly located in the area on the right side of the photograph.

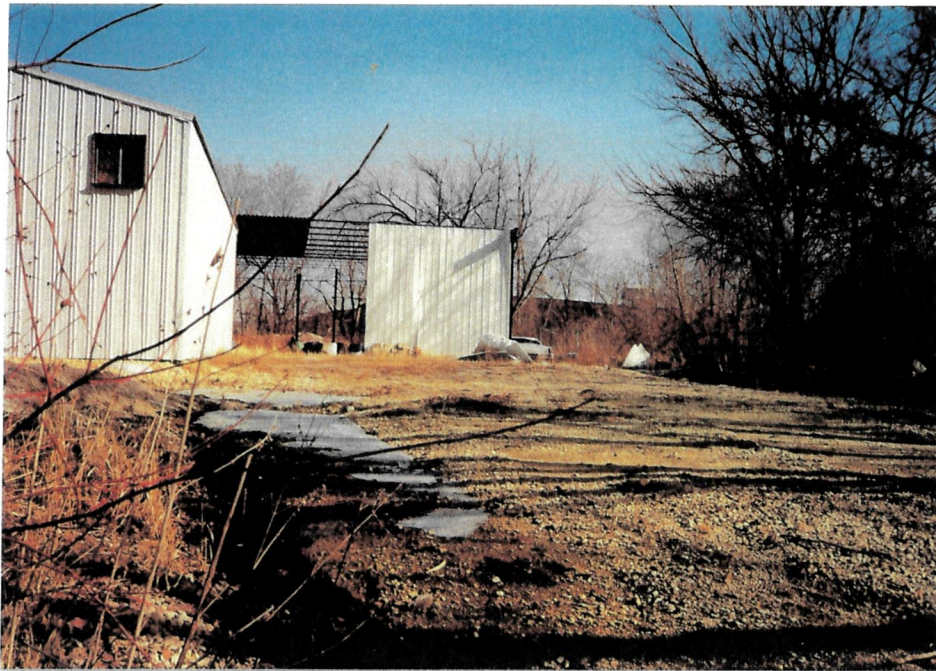
Dynamac observed the area where the unlined pit was formerly located and the USTs are currently located (see Photo No. 3). The area was covered with gravel and the USTs were not visible. There was no visible evidence of a previous release. Dynamac also observed the outfall area near the Des Plaines

River; the surrounding area did not have any stains or evidence of a previous release.

**Photo No.:** 3 **Location:** SWMU 3  
**Orientation:** East **Date:** February 4, 1993  
**Description:** Area along the south side of the building where SWMU 3 was located. According to the facility owner, the two 500-gallon steel underground storage tanks (UST) are still located in the area and have been filled with clean water.

**Recommendations:** Dynamac recommends that the facility conduct RCRA closure for this unit. The RCRA closure should include soil sampling for VOCs and heavy metals in the vicinity of the unit and sediment sampling for the same parameters where the surface water runoff from the unit discharges to the Des Plaines River. If soil or sediment is found to be contaminated, the facility should also conduct groundwater sampling to determine whether groundwater has been affected.

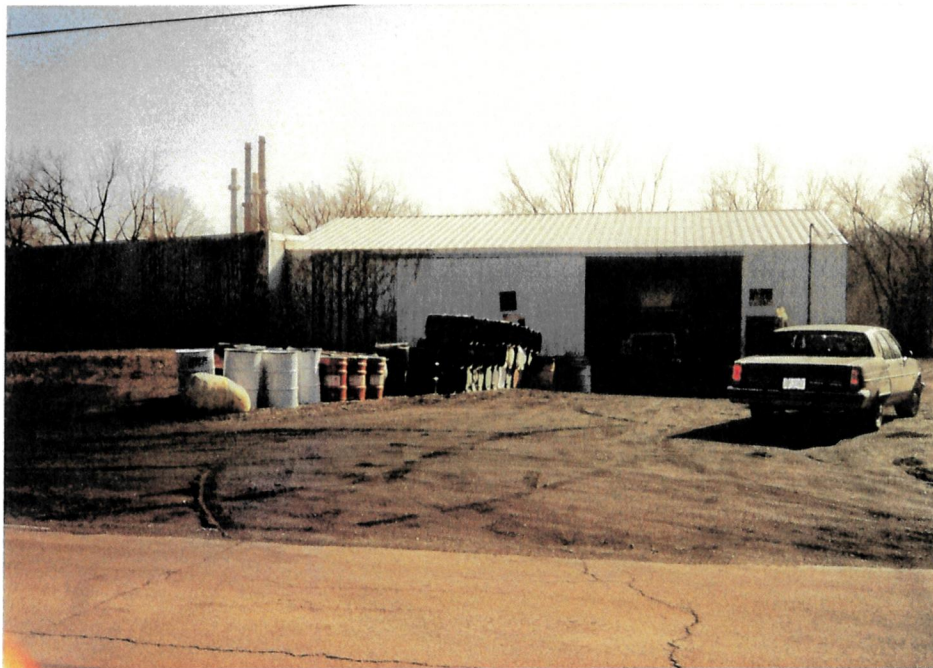
**Photo No.:** 4 **Location:** SWMU 1  
**Orientation:** South **Date:** February 4, 1993  
**Description:** Approximately 40 55-gallon steel drums in the Front Drum Storage Area. These drums formerly contained dairy products and other food products.

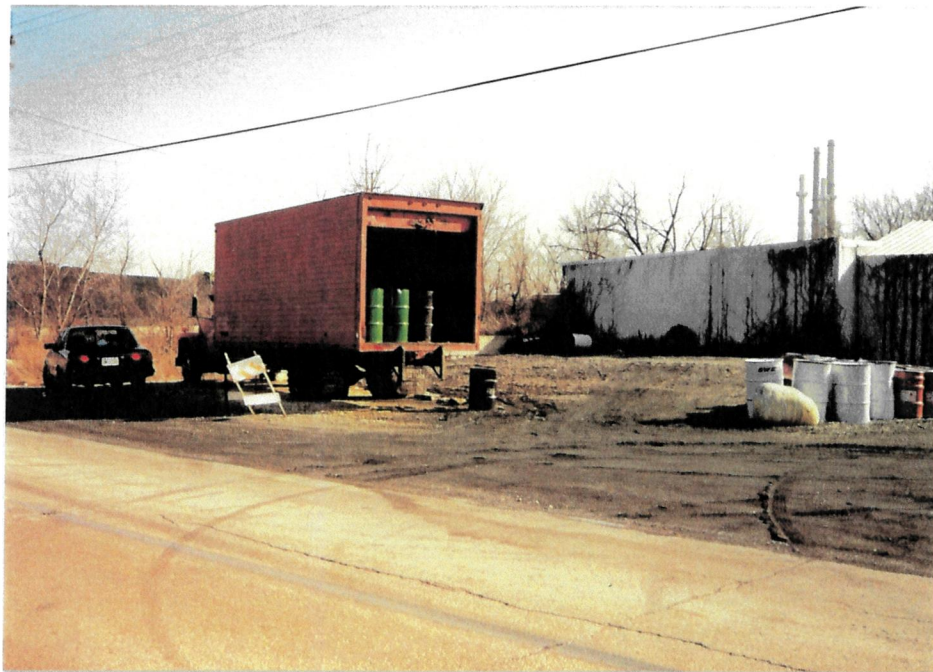
**Photo No.:** 5 **Location:** North side of facility  
**Orientation:** Southeast **Date:** February 4, 1993  
**Description:** Truck located on north side of building containing 55-gallon steel drums.

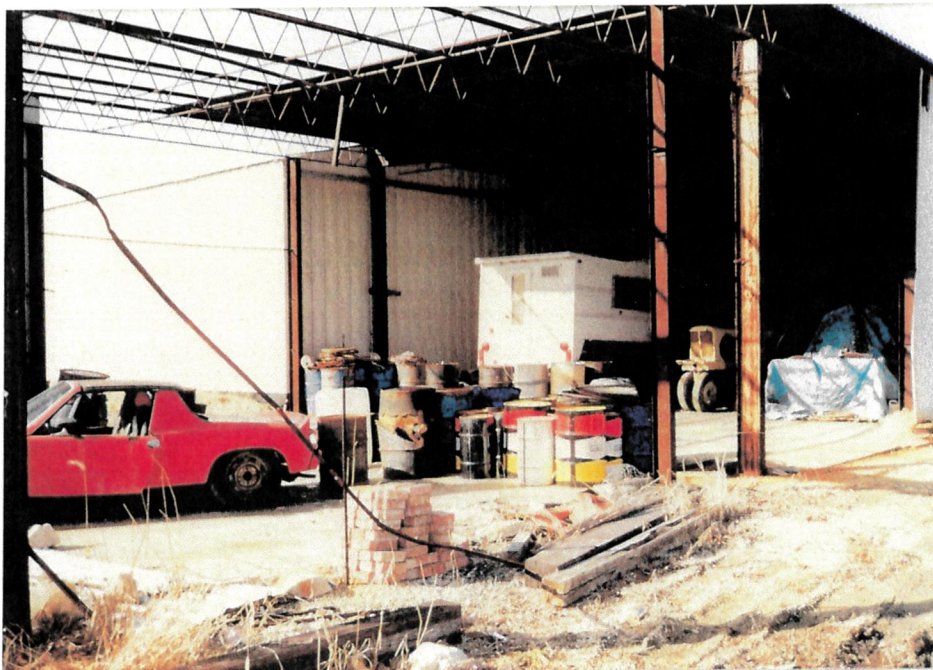
At the time of the VSI, the unit contained approximately 30 empty drums. There were no stains or evidence of a previous release on the concrete pad associated with this unit (see Photo No. 6).

**Photo No.:** 6 **Location:** SWMU 2  
**Orientation:** Northwest **Date:** February 4, 1993  
**Description:** Approximately 30 55-gallon steel drums located in the Rear Drum Storage Area. These drums formerly contained molasses and other food products.

The facility should also continue to monitor all drums brought to the facility and inspect this unit to verify no drums with hazardous waste residue are present. If detected, such drums should be immediately closed and transported off-site to a permitted RCRA TSD facility for disposal.

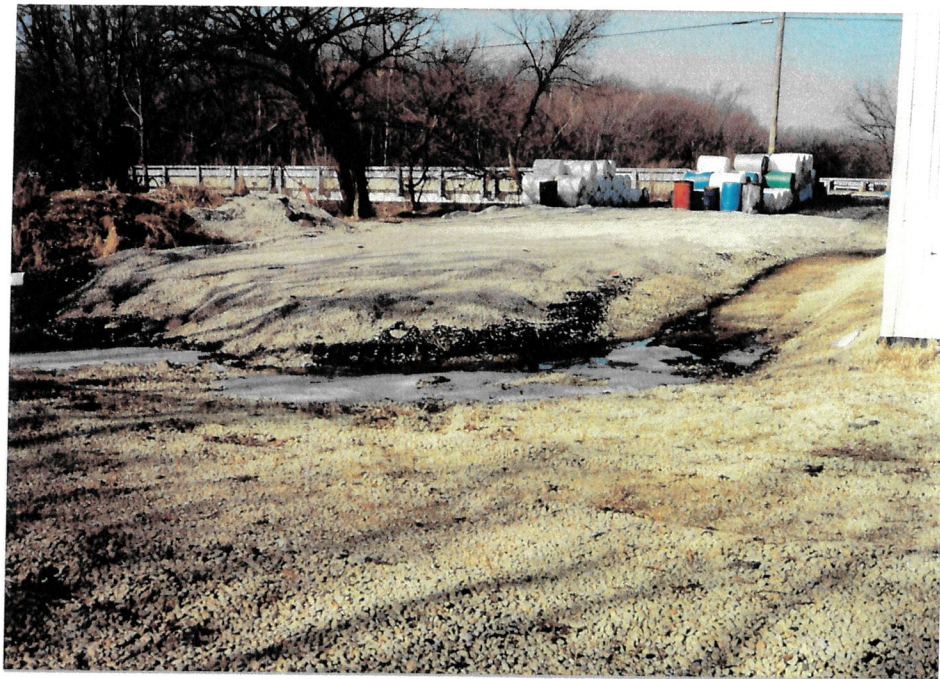
**7**

**Northern portion of the unlined trench that directs surface water runoff from SWMU 1 to the Des Plaines River.**

**Recommendations:** Dynamac recommends that the facility conduct soil sampling for volatile organic compounds (VOC) and heavy metals in the vicinity of the unit and the unlined trench and sediment sampling for the same parameters where the unlined trench discharges to the Des Plaines River. If soil is found to be contaminated, the facility should also
